7 Site Management: Cleaning and Reconstruction of the Balustrade around the Naos of Petosiris (GB 50) – Some Observations

7.1 *The balustrade*

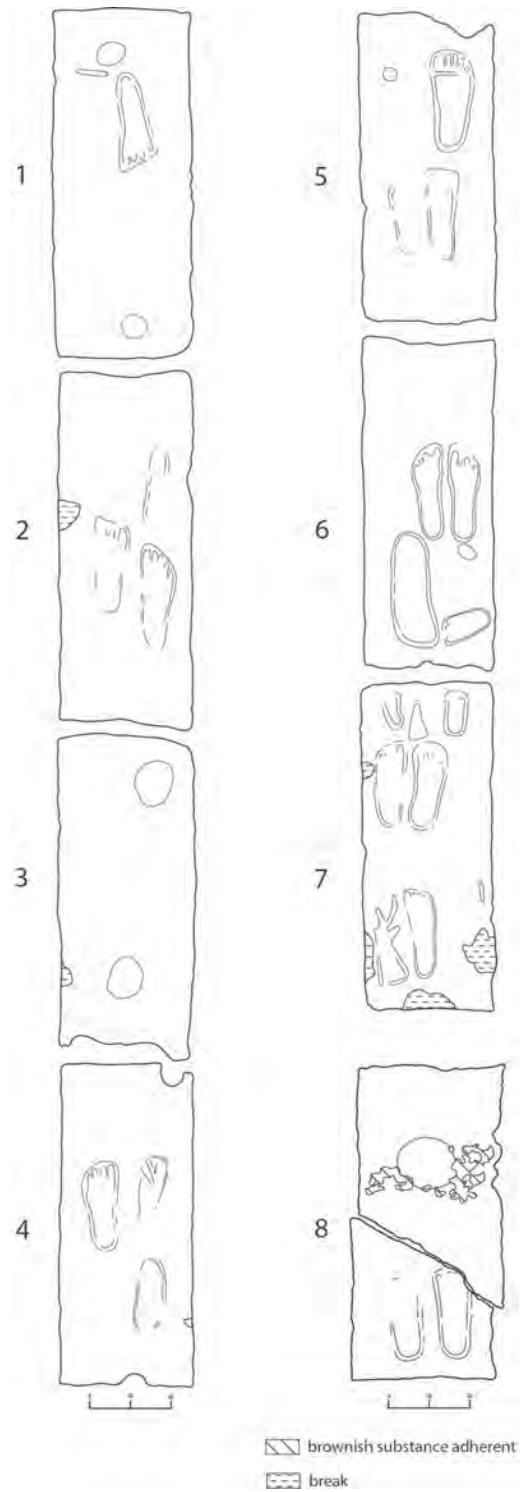
Fig. 4: The seven complete slabs and one of the broken slabs once supported by the pillars, showing incised outlines of feet and offering moulds; 2015

in length and 17 cm in thickness⁸. Seven of these slabs are still complete, two are broken in two pieces, and several further fragments have been found during cleaning the surroundings from sand. On seven of those slabs (six are complete and one is broken) the outline of a single foot or of a pair of feet is incised (fig. 4)⁹. They are of different sizes, and some smaller ones appear to belong to children. The toes are not always indicated; on a single foot on slab no. 5 a sandal seems to be indicated by a horizontal line incised directly below the toes. Most of the incised feet are pointing north, only two feet (slabs nos. 1 and 6) are pointing south¹⁰ and another foot (slab no. 6) is the only one pointing west. A pair of feet on slabs nos. 4 and 7 seems to be unfinished, which is suggested by the weak and incomplete incision of the second foot.

In addition, five slabs show offering moulds (fig. 4). Similar moulds appeared also at the euthyteria of GB 51 and the tomb of Padjkam (GB 54)¹¹. It is so far unclear, if those offering moulds were part of the funerary cult for Petosiris himself or if they belong to later burials that once surrounded the tomb.

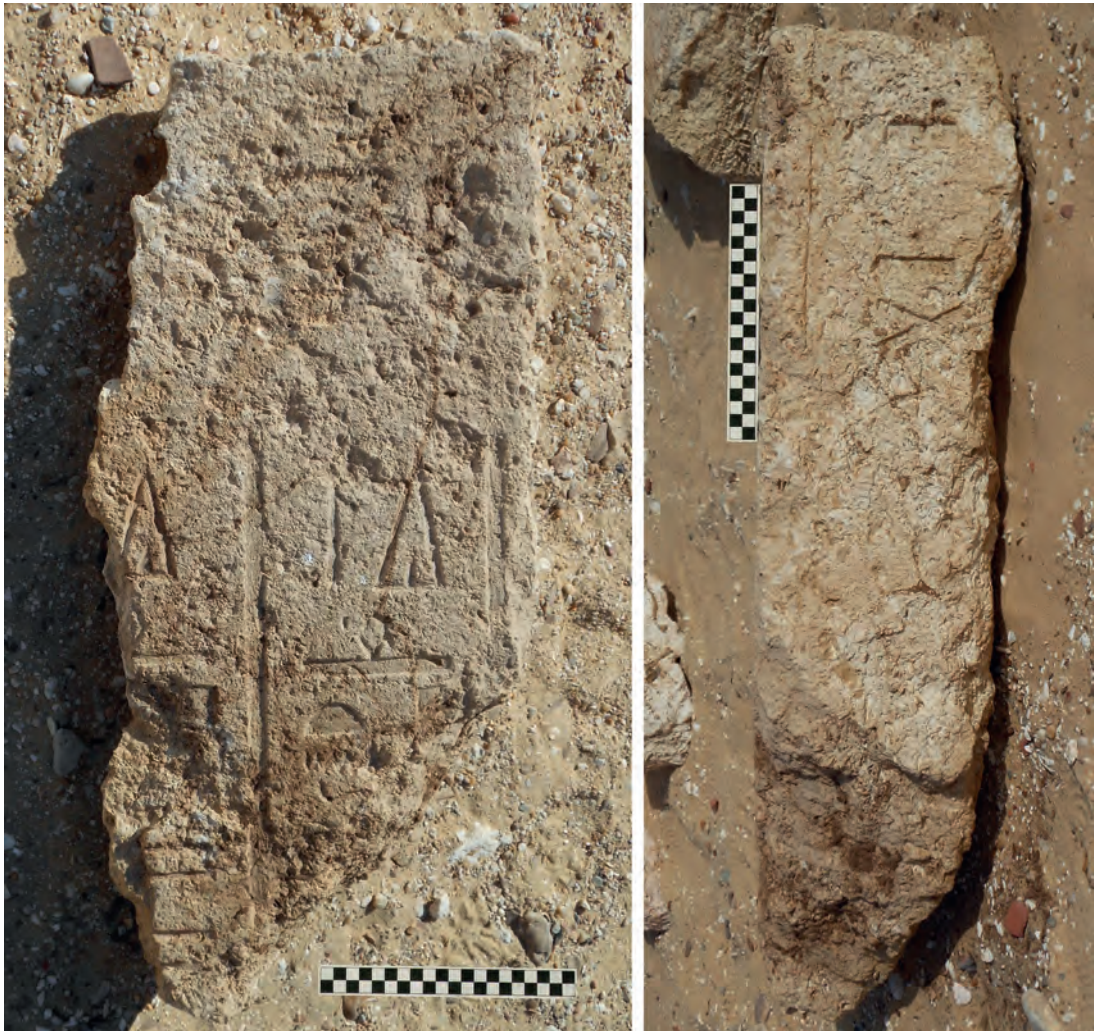
Fig. 8: Photo of the same block bearing a hieroglyphic inscription; 2015

On the southern side, two fragmented blocks with hieroglyphic inscriptions in sunk relief were found among the scattered blocks. Most likely, they belong to the tomb of Petosiris (GB 50) and were part of the architraves once supporting the ceiling blocks. Both preserve an original edge of the block and bear traces of hieroglyphic inscriptions arranged in columns on two sides (fig. 7–9).

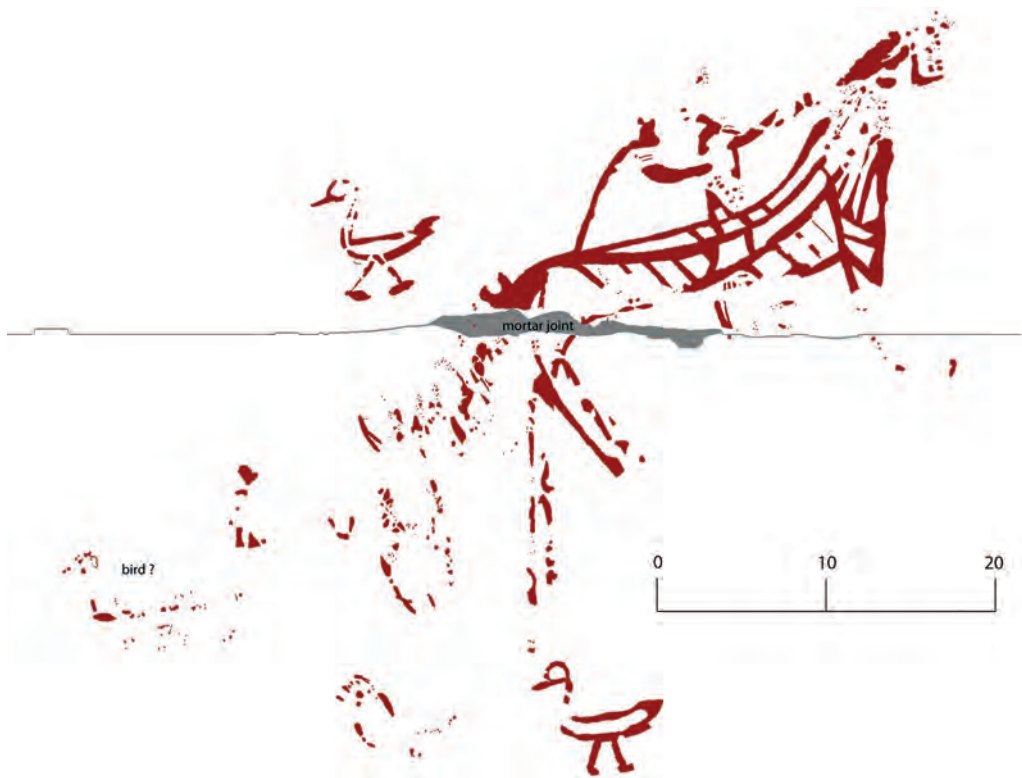
Fig. 10: Graffito depicting a horseman (?) and some birds; 2015

At the bottom part of the eastern wall near the corner of the hall, graffiti in red ink of a horseman (?) facing to the right and of at least two small birds facing to the left were found (fig. 10), which had not been documented by

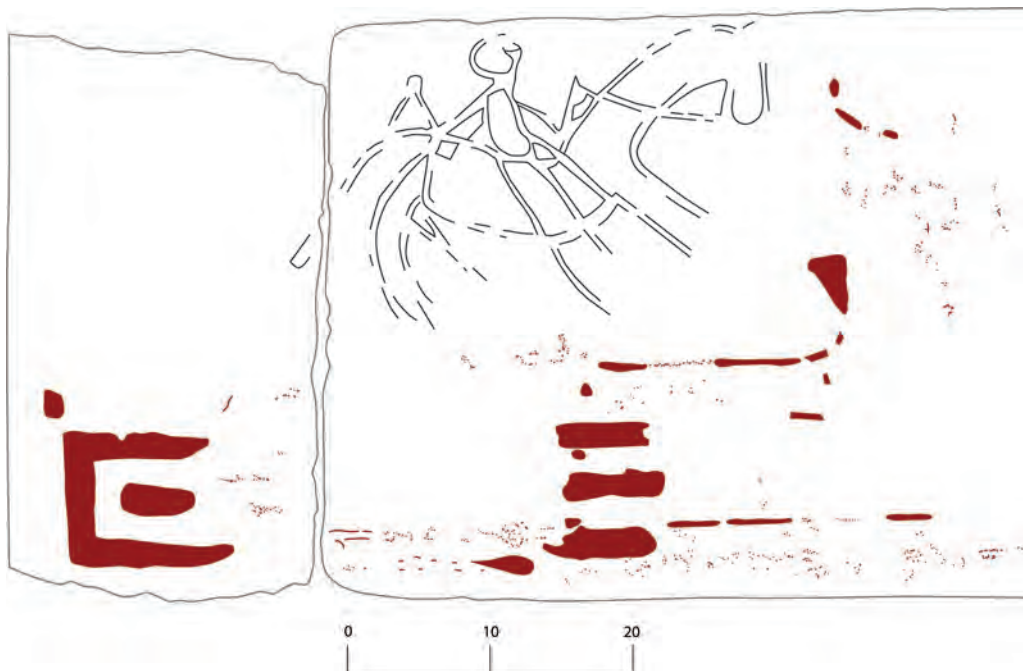
Fig. 11: Temple tomb of Padjkam (GB 54), eastern wall of the pronaos, graffito depicting a horseman; 2015

Lefebvre nor by Gabra. Another incised depiction of a horseman (fig. 11) and traces of red paint were found on the eastern wall of the pronaos of the temple tomb of Padjkam (GB 54)¹⁹.
